An Architectural & Financial
Feasibility Study

the Historic Masonic Lodge Building

the City of Winters

May 1995

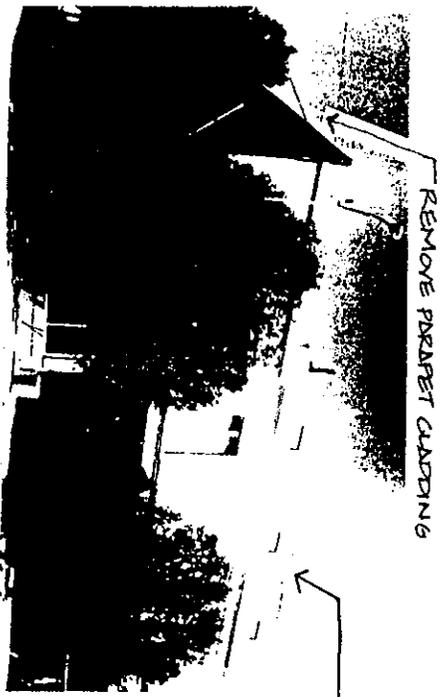
MAIN STREET FACADE

REMOVE PARAPET CLADDING

The parapet along the west side wall facing First Street has been covered over with a non-historic shingled/plywood mansard cap. This cap should be removed and the underlying brick parapet repaired to its original configuration.

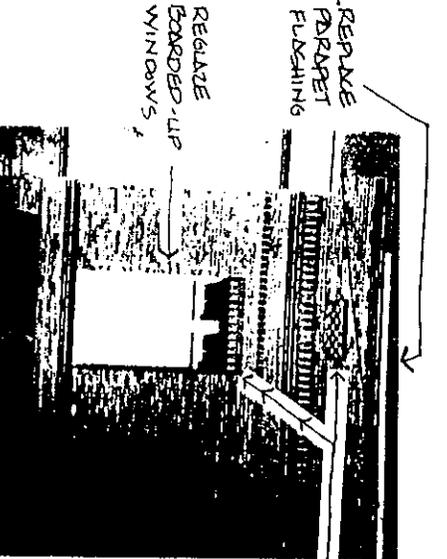
REPLACE
PARAPET
FLASHING

REGLAZE
BOARDED-UP
WINDOWS

It is recommended that a new, properly installed parapet flashing cap be installed over all of the parapets. The existing metal flashing, used only to patch parapet failures, should be entirely removed. A continuous new watertight flashing should be installed and painted to blend with the facade.

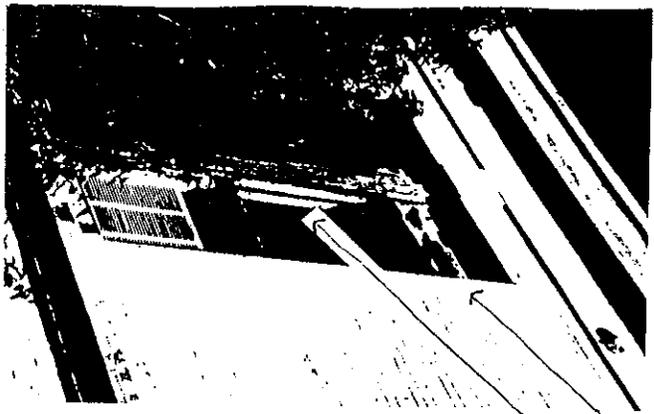
DROTTE
WINDOW
SASH
BROKEN GLASS

REPLACE
NON-
HISTORIC
STORE-
FRONT

The entire ground floor facade is very unattractive. It does not take advantage of the historic appearance of the remainder of the building. We recommend that the west building's existing "modern" storefront be entirely removed and that a new facade be reinstated, recalling the building's historic character. The east building's storefront should be rebuilt to conform to the original location, reusing the existing historic materials.
