City of Winters

Date: December 2009

Downtown Winters Feasibility Market Study

KPFF Consulting Engineers

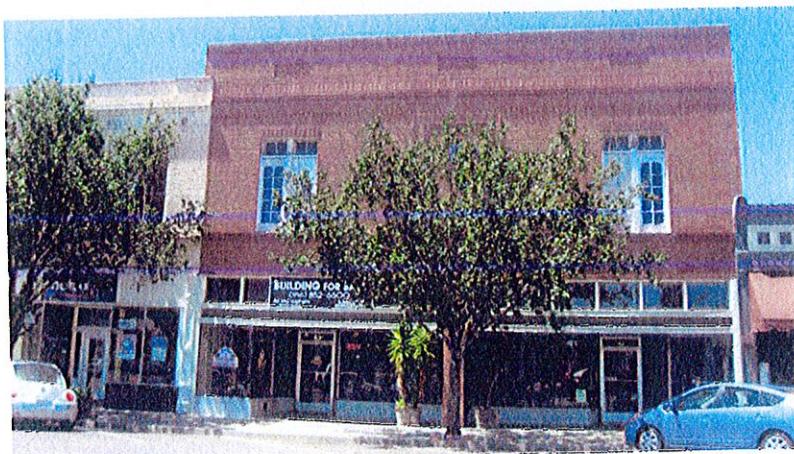
Figure 2 – Front Elevation of the Masonic Building

The Masonic building is a two-story unreinforced masonry structure, which consists of two adjacent buildings that share a common wall. It is understood that the east building was constructed first and was originally a one-story building. The second story to that building and the two story adjacent building were constructed at a later date. As shown in Figure 2, the east building is approximately five feet taller than the west building.

The interior wall that separates the two buildings and exterior walls are unreinforced masonry. These walls support the floors and roof and also provide lateral resistance to wind and seismic loads. The first floor of both buildings is a raised wood floor with a basement under the western building. We were unable to determine if there was an access/crawl space under the eastern building. The framing of the first floor consists of straight sheathing over nominal framing members spaced at 16” – 24”o.c. We were unable to gain access to the first floors, but from observing through the first floor windows and from the second floor, it appeared that the second floor was framed similar to the first with flat sheathing over nominal framing members. The roof framing consists of flat straight sheathing over wood framed trusses that span between the brick walls.

The first and second floor framing, in general, appears to be in fair condition. From the limited access we had, we observed a small amount of water damage which caused warping of framing members. The floor covering of the west building had extensive water damage but it didn't appear to have had an affect on the floor framing. There was no noticeable slope to the floor.

Structural upgrades that are required for the Masonic building include repairing damaged roof and floor framing as required to restore the structural integrity of the existing floor, replacing damaged sheathing and repairing the cracked masonry walls. The damaged framing can be repaired by reinforcing with additional wood framing or replacing with new framing. The exterior cracked masonry walls can be patched with a crack injection system and further cracking can be prevented with new steel headers above existing windows where cracking has occurred.

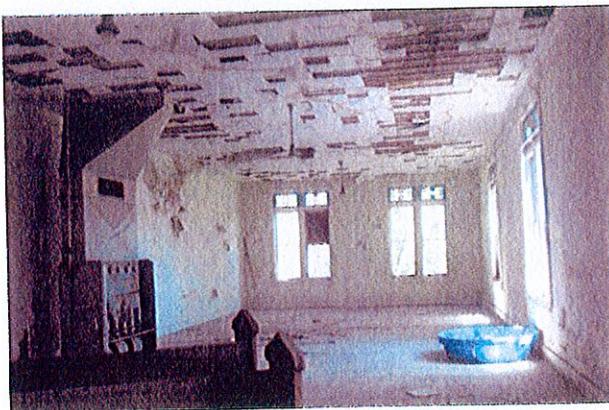
Figure 3 – The Masonic West Side Second Floor

The roof truss building seemed to although the roof appear to have water Figure 3 below.

framing in the west be in fair condition, sheathing and ceiling damage as shown in

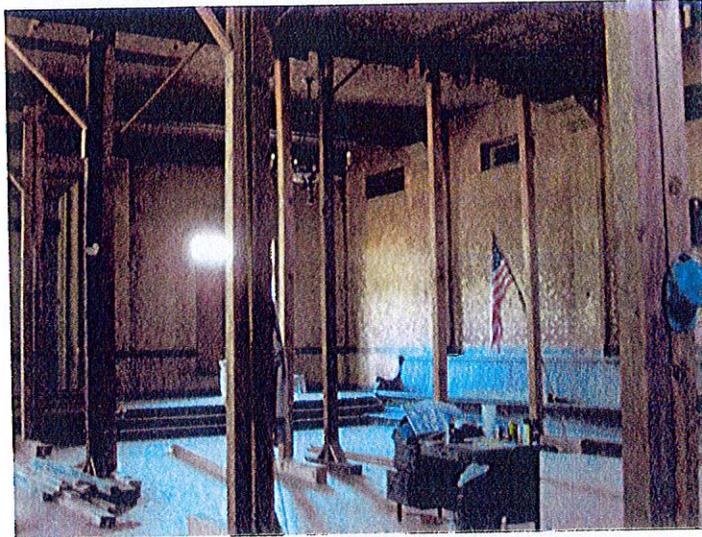
Figure 4 – The Masonic East Side Great Room

The wood roof trusses spanning 48 feet over the great room in the east building are currently being shored by a wood post and beam system as shown in Figure 4 below. From existing drawings dated April 12, 1991, provided by the owner, it appears that an attempt was made to repair the wood trusses by shoring the trusses and repairing cracks in the trusses with a wood epoxy. It is unclear if the repair work was completed. According to existing documents, dated November 30, 1998, the existing shoring was added in 1998 as part of a tenant improvement allowing occupancy of the first floor. The same documents include strengthening of the first floor framing. The existing ceiling prevents access to observe the existing trusses and determine their current condition.

Required	
Roof truss repair/replacement at great room =	\$ 80,000
Roof truss repair at north wall =	\$ 40,000
Minor repair to other wood framing =	<u>\$270,000</u>
Total Estimate	\$390,000 (Approx. \$29 / sq ft.)
Voluntary – Highly Recommended	
Wall attachment to floor and roof =	\$126,000
Moment/Brace frame at store front =	\$200,000
Remove/Brace Parapets =	<u>\$ 9,000</u>
Total Estimate	\$335,000 (Approx. \$25 / sq ft.)
Voluntary – Recommended	
20% of brick walls to be repaired =	\$108,000
Bracing of walls out of plane =	\$182,000
Bracing between roofs =	<u>\$ 20,000</u>
Total Estimate	\$310,000 (Approx. \$23 / sq ft.)
Total Estimate	\$1,035,000 (Approx. \$77 / sq ft.)

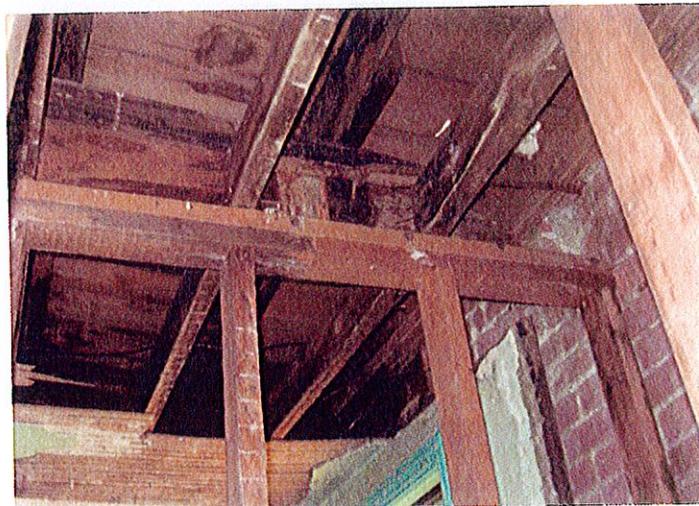
Figure 5 – Existing Trusses at the North Wall

The roof trusses along the north wall as shown in Figure 5 below appear to be rotted at the ends and no longer bear on the existing wall. Areas of the roof sheathing have also been water damaged.

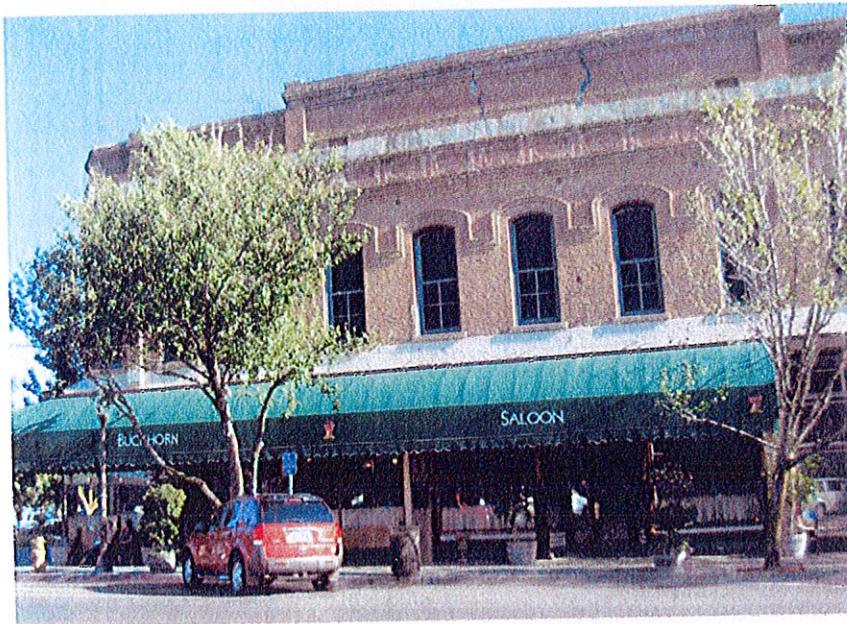
Figure 6 – North Elevation of the Buckhorn Building

According to historical data, the Buckhorn Building was originally built in 1889. It is a two-story L-shaped building and has retained its original footprint. The exterior walls are of unreinforced masonry construction as shown in Figure 6 below. They support the floors and roof and also provide lateral resistance to wind and seismic loads.

The first floor is a raised wood floor with a partial basement under the west side of the building. We were unable to determine if there was an access/crawl space under the east side of the building. It is assumed that the first floor is framed with straight sheathing over nominal framing members spaced at 16" – 24" o.c., similar to that of the Masonic building. The first floor was accessible, but the ceiling and finishes prevented observation of the second floor framing. From the second floor above, it appeared that the second floor was framed consistent with the other buildings with flat sheathing over nominal framing members. The roof framing consists of built up 2x wood joists supported by posts bearing on the wood and brick walls below.

The first and second floor framing in general appears to be in fair condition. Because of limited access, only a small amount of water damage and warping of the existing floor framing was observed. There was no noticeable slope to the floors. The built up roof framing appeared in good condition, however a portion of the north roof framing had been slightly damaged by a previous fire. It appears that additional wood framing was added to provide structural reinforcement of the damaged framing. According to the owner, re-roofing had occurred within the last couple of years and seismic strengthening of the building was done

Structural upgrades required for the Buckhorn building includes repairing damaged roof and floor framing, replacing damaged sheathing as required to maintain the structural integrity of the existing floor and roof and repairing both the minor and major cracks at the masonry walls. The damaged framing can be repaired by reinforcing with additional wood framing or replacing with new framing. Minor cracks at

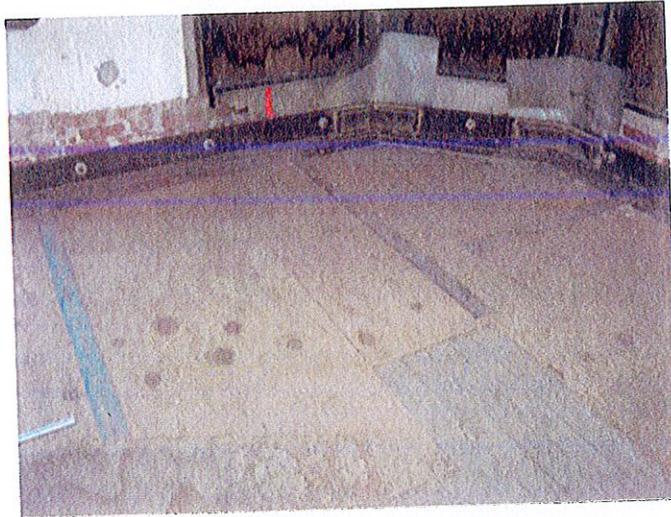
Figure 7 – Structural Reinforcement

in 1997. This was achieved by tying the exterior wall to the second floor and roof through the use of steel plates, anchor bolts, steel angles, and wood sheathing at both levels as shown in Figure 7 below. In addition it appears that the brick parapet was tied to the existing roof using wood bracing and sheathing.

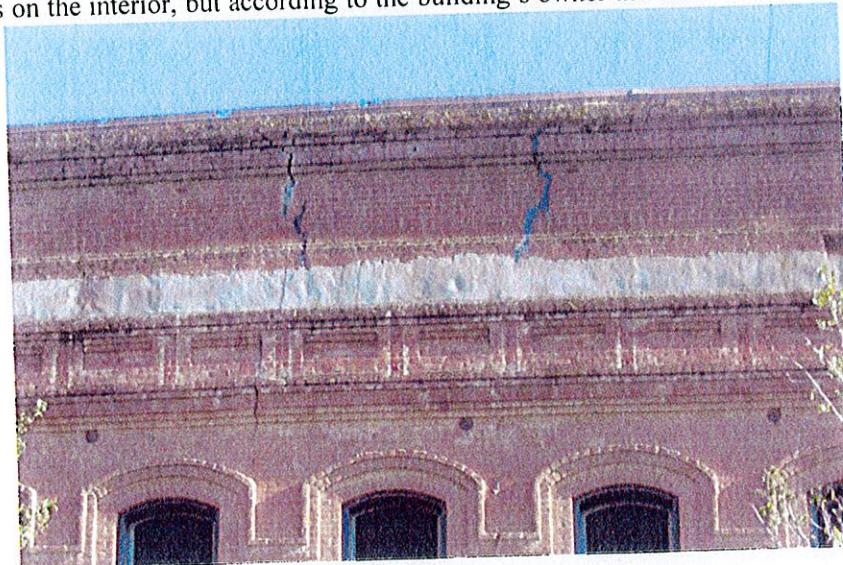
Figure 8 – Cracks in Brick Wall at the North Elevation

In general, the exterior brick walls appeared to be in good condition. However at the top of the north exterior wall, large cracks are apparent, both on the inside and the outside of the building, as seen in Figure 8 below. There have been attempts to repair the cracks with grout and tying the wall together with plates and bolts on the interior, but according to the building's owner the cracks have been getting larger.

The cracks appear to coincide with the delineating line between the portions of the building located over a basement and the portion without a basement.

the exterior masonry walls can be patched with a crack injection system and further cracking can be prevented with new steel headers above existing windows where cracking has occurred. At the major cracks along the north wall of the building foundation strengthening may be required if it is determined that foundation settlement is causing the cracking. The strengthening may be achieved through a micro-pile or concrete cassion system that would provide stability under the existing foundation and prevent future settlement.

Required	
Foundation strengthening =	\$ 200,000
Minor repair to wood framing =	<u>\$ 325,000</u>
Total Estimate	\$ 525,000 (Approx. \$33 / sq ft.)
Voluntary – Highly Recommended	
Moment/Brace frame at store front =	<u>\$ 200,000</u>
Total Estimate	\$ 200,000 (Approx. \$12 / sq ft.)
Voluntary – Recommended	
20% of brick walls to be repaired =	\$ 100,000
Bracing of walls out of plane =	<u>\$ 170,000</u>
Total Estimate	\$ 270,000 (Approx. \$17 / sq ft.)
Total Estimate	\$ 995,000 (Approx. \$62 / sq ft.)

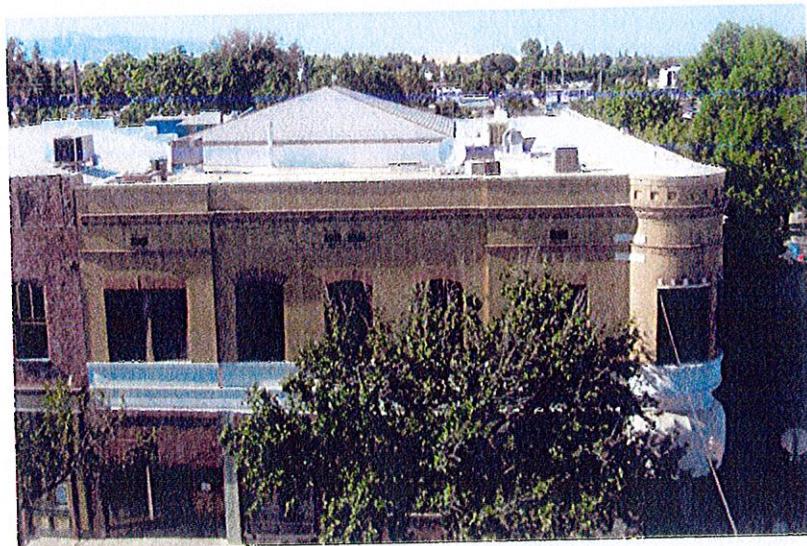
Figure 9 – The Putah Creek Café Building

The Putah Creek Café Building was built in 1904. It appears to share a common wall with the Opera House building to the west that was built at an earlier date.

The exterior walls are unreinforced masonry. They support the floors and roof and also provide lateral resistance to wind and seismic loads. The first floor is a wood raised floor with a partial basement under the north side of the building. It could not be determined if there was an access/crawl space under the south side of the building. It is assumed the first floor is framed with straight sheathing over nominal framing members spaced at 16" – 24" o.c similar to the other buildings. The first floor was accessible, but the ceiling and finishes prevented observation of the second floor framing. But from the second floor above, it appeared that the second floor was framed consistent with the other buildings with flat sheathing over nominal framing members. The roof framing consists of built up 2x wood framing and posts bearing on the wood and brick walls below. There is a portion of the roof framing that elevates above the rest of the roof framing as shown in Figure 9 above.

The first and second floor framing, in general, appeared to be in fair condition. From the limited access only a small amount of water damage and warping of the existing floor framing was observed. In general there was no noticeable slope to the floors. The built up roof framing appeared to be in good condition.

In general the exterior brick walls appear to be in good condition except for some cracks above and below windows at the west wall.

Structural upgrades required for the Putah Creek Café building would include repairing damaged roof and floor framing as required to maintain the structural integrity of the existing floor, replacing damaged

sheathing and repairing the cracked masonry walls. The damaged framing can be repaired by reinforcing with additional wood framing or replacing with new framing. The exterior cracked masonry walls can be patched with a crack injection system and further cracking can be prevented with new steel headers above existing windows where cracking has occurred.

Required	
Minor repair to floor wood framing =	\$121,000
Moderate repair to roof wood framing =	<u>\$182,000</u>
Total Estimate	\$303,000
	(Approx. \$25 / sq ft.)
Voluntary – Highly Recommended	
Wall attachment to floor and roof =	\$106,000
Moment/Brace frame at store front =	\$200,000
Remove/Brace Parapets =	<u>\$ 6,000</u>
Total Estimate	\$312,000
	(Approx. \$26 / sq ft.)
Voluntary – Recommended	
20% of brick walls to be repaired =	\$ 85,000
Bracing of walls out of plane =	<u>\$142,000</u>
Total Estimate	\$227,000
	(Approx. \$19 / sq ft.)
Total Estimate	\$ 842,000 (Approx. \$70 / sq ft.)

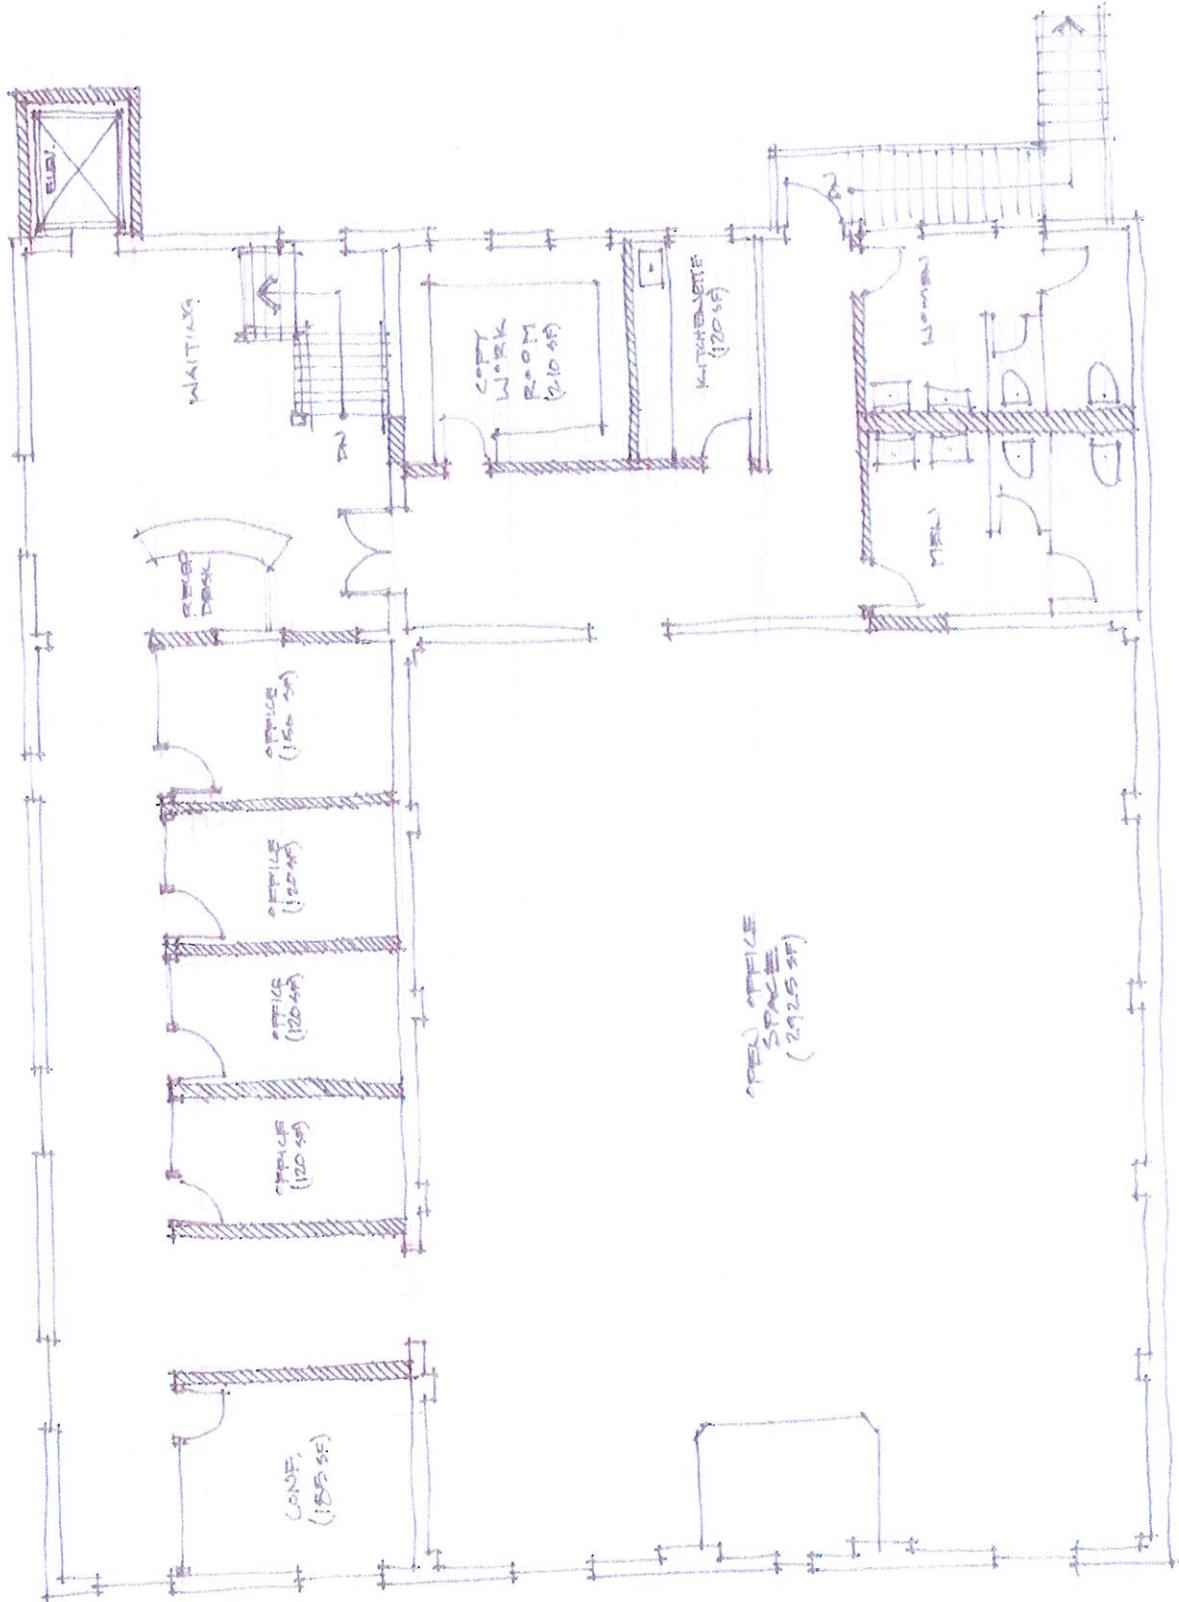
MASONIC LODGE
UPPER FLOOR
OFFICE SCHEME

OPEN OFFICE
SPACE
(2925 SF)
