PRELIMINARY DELINEATION OF WATERS OF THE UNITED STATES,
INCLUDING WETLANDS, FOR THE

PG&E WINTERS GAS OPERATIONS TECHNICAL TRAINING CENTER (GOTTC)

February 2015

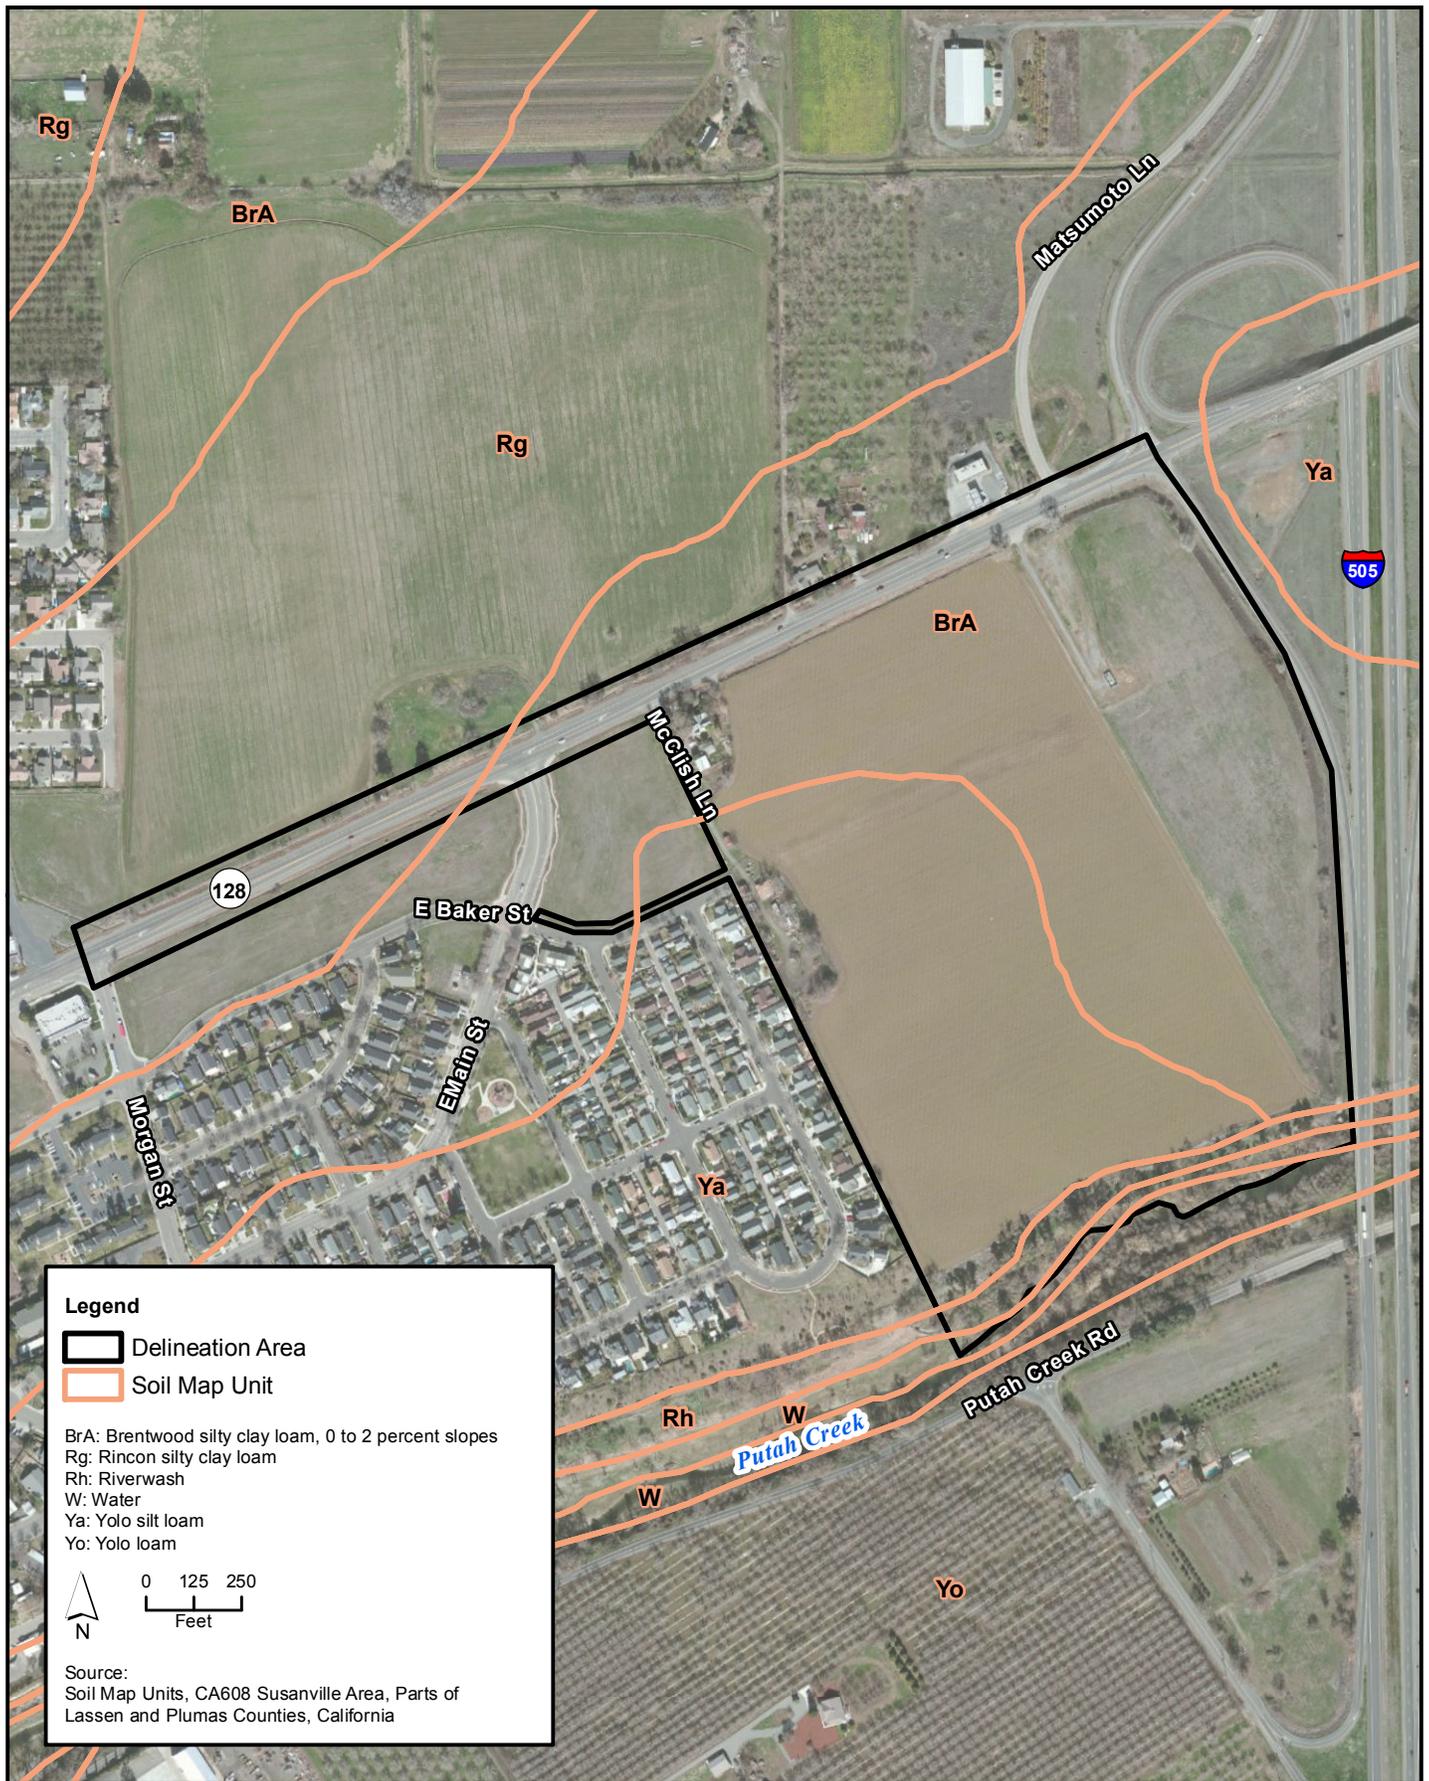
Figure 2
Soils in the Delineation Area

Five soil mapping units underlie the Delineation Area (NRCS 2015a, Appendix D, Figure 2): “Brentwood silty clay loam, 0 to 2 percent slopes,” “Rincon silty clay loam,” “Riverwash,” “Water,” and “Yolo silt loam” (Appendix D). The NRCS did not provide a hydric description for the “Water” mapping unit, but this mapping unit appears to be limited to approximately the footprint of Putah Creek (Figure 2), and is assumed to apply to areas that are flooded for a very long time during the growing season. Of the remaining four mapping units, all are formed from alluvium and fill from sedimentary sources. Two of the four have hydric status: “Riverwash,” which is associated with streams and is frequently flooded for long or very long duration during the growing season; and “Yolo Silt Loam,” whose inclusions of “Sycamore” soils found on alluvial fans are also hydric (NRCS 2015b).

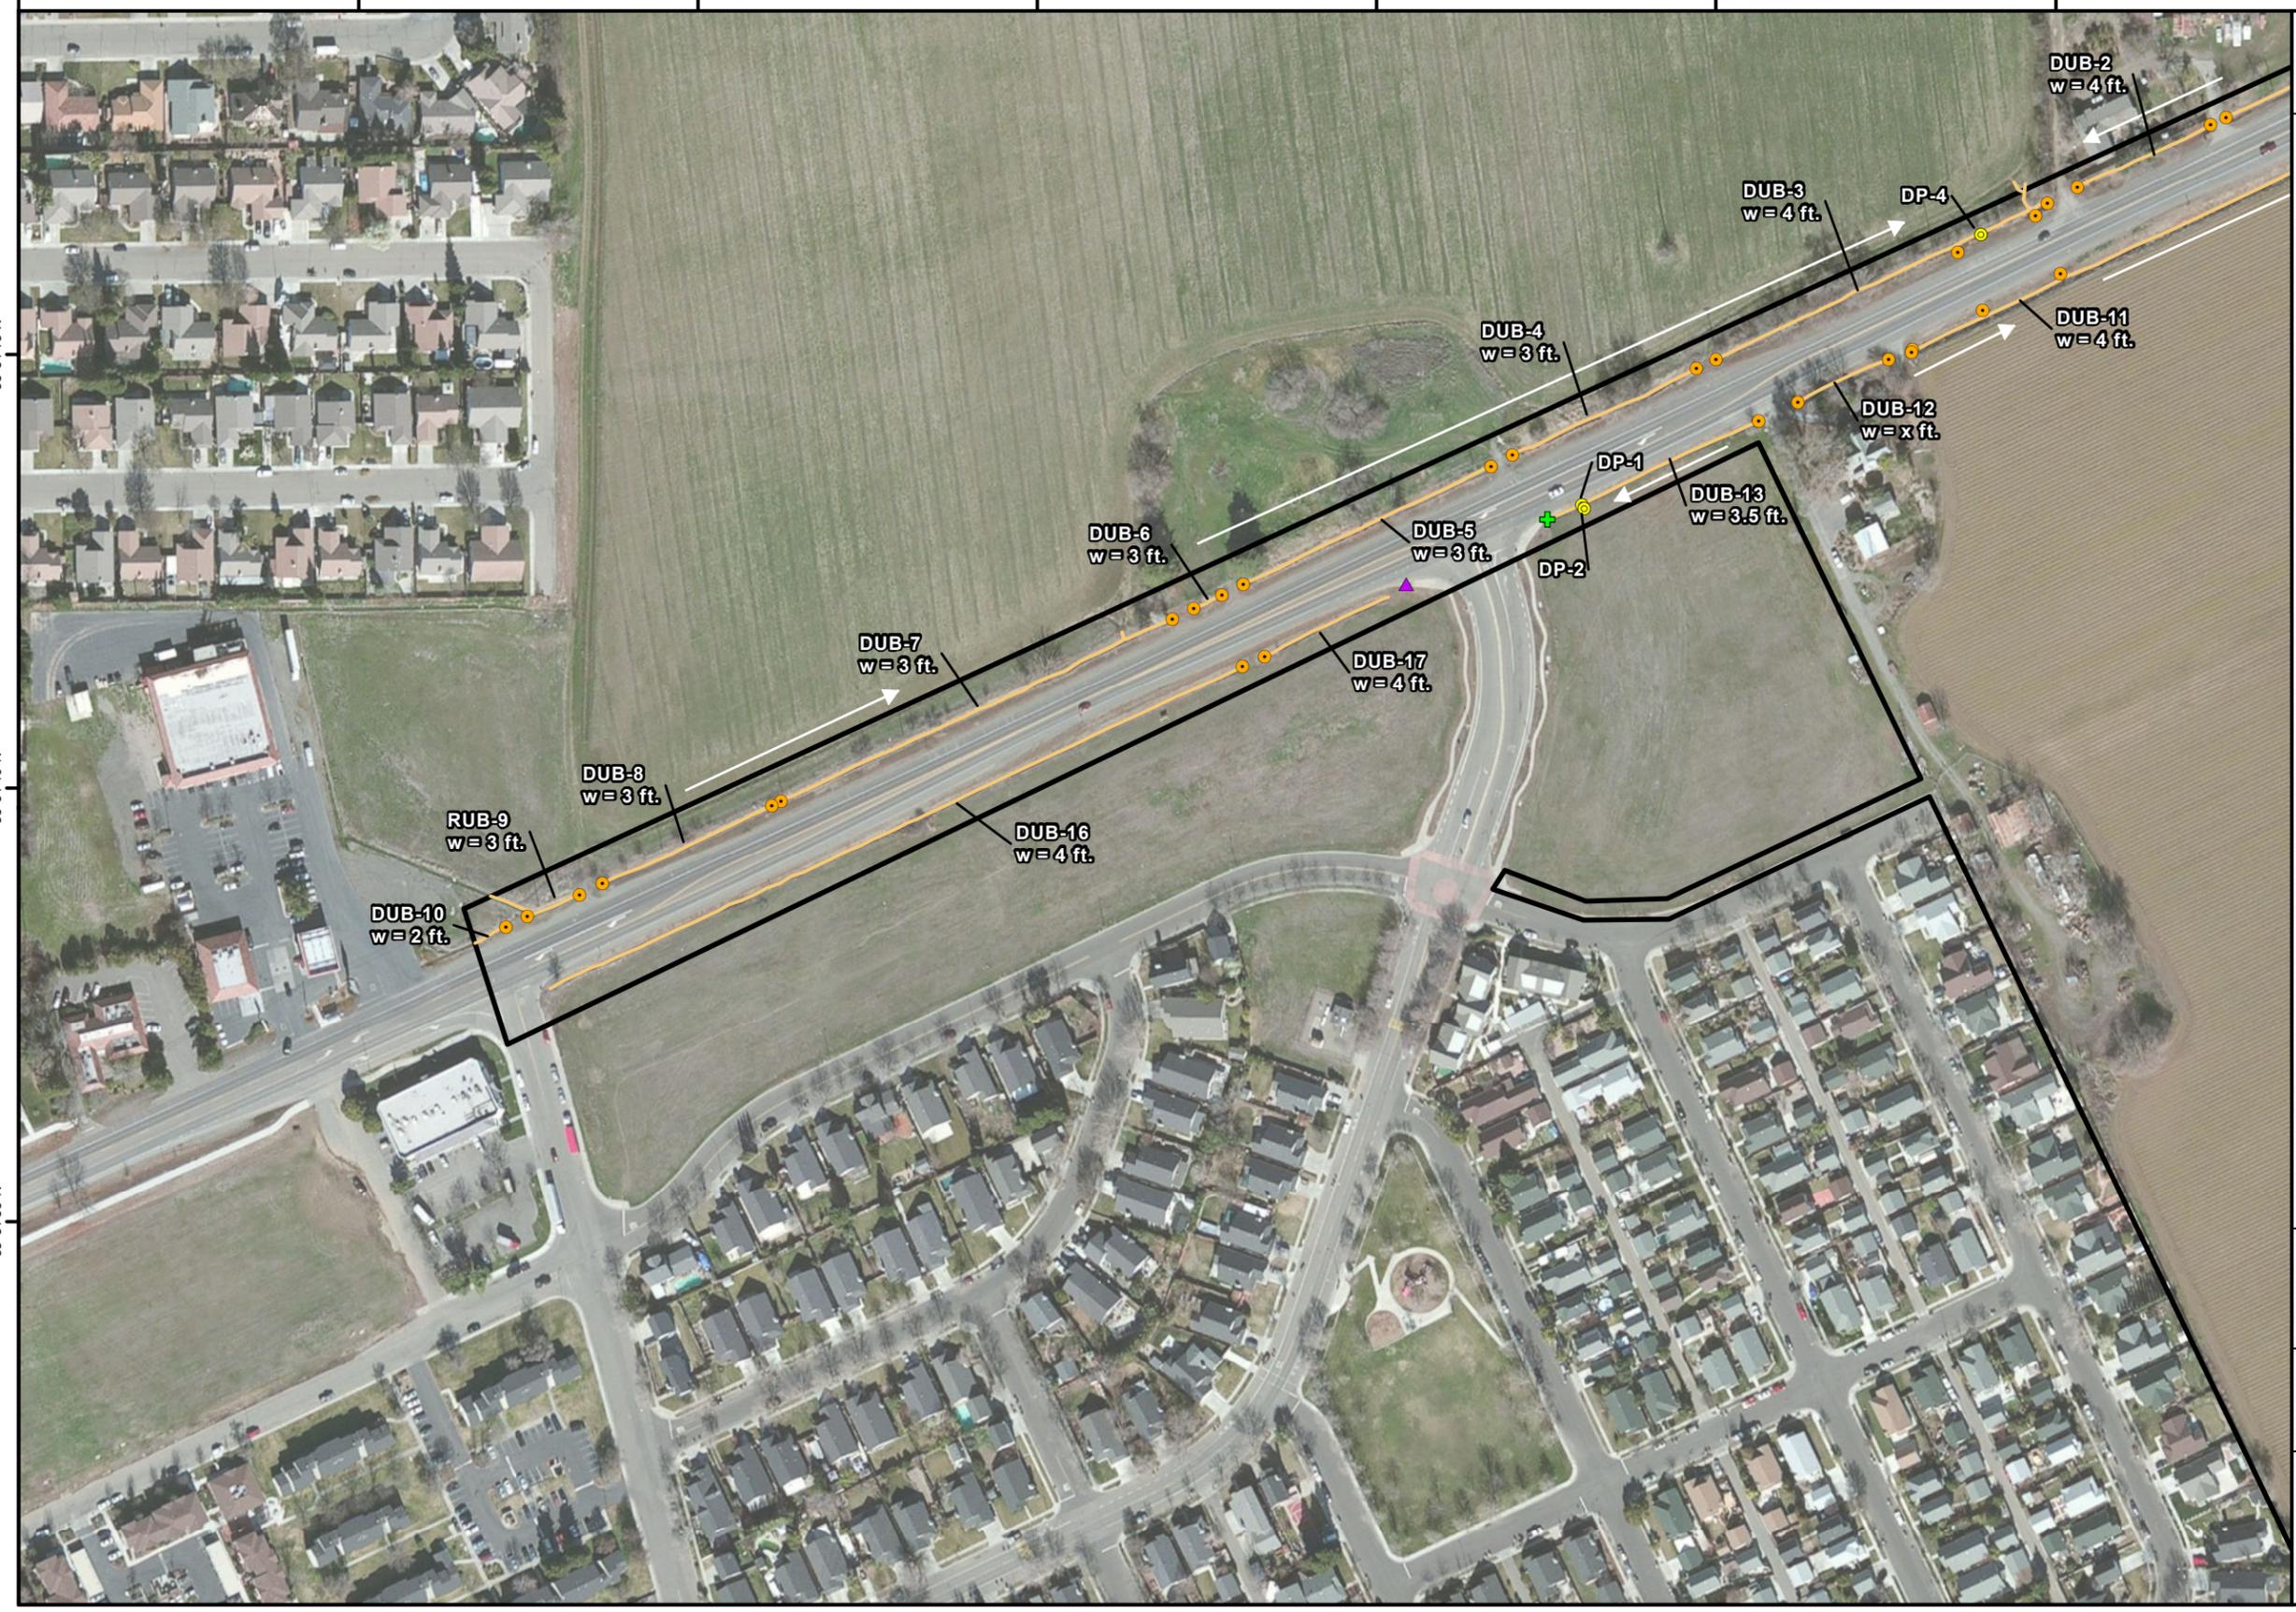
Imagery Source: ESRI World Imagery (2010)
USGS Topo Quad: Winters (1978)
PLSS: Section 22; Township: 8N; Range: 01W

PG&E Contact: Ryan Brown
Prepared by: Garcia and Associates/530-588-3515
Delineated by: Samantha Hillaire and Susan Dewar
Delineation Survey Date: 01-08-2015, 01-22-2015
Drawn By: Karen Klinger

*System: P = Palustrine, R = Riverine, D = Nonjurisdictional Ditch, *Class: UB= Unconsolidated Bottom, EM = Emergent Vegetation, SS = Scrub-Shrub, r = Artificial

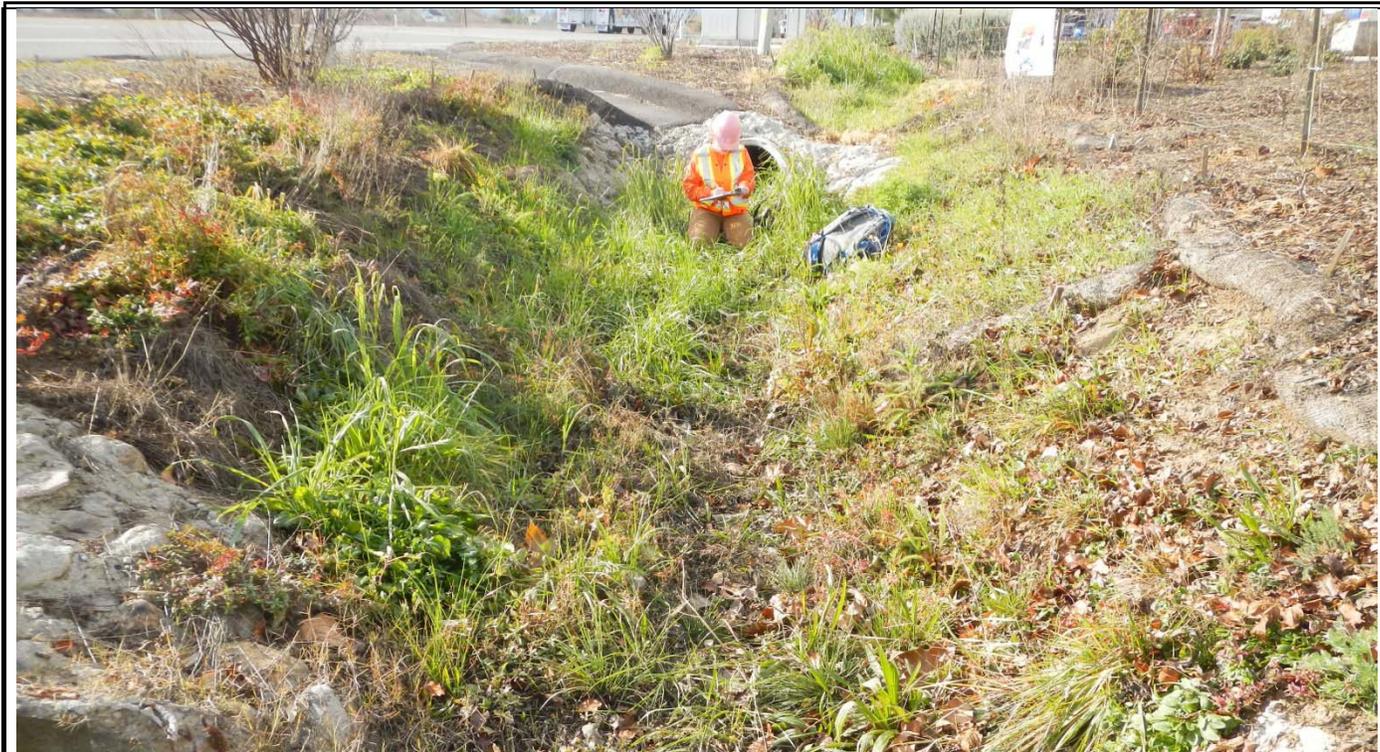
Photo 1. Palustrine emergent wetland feature (PEM-1) at location of DP-3. North side of SR 128, facing west, January 8, 2015.

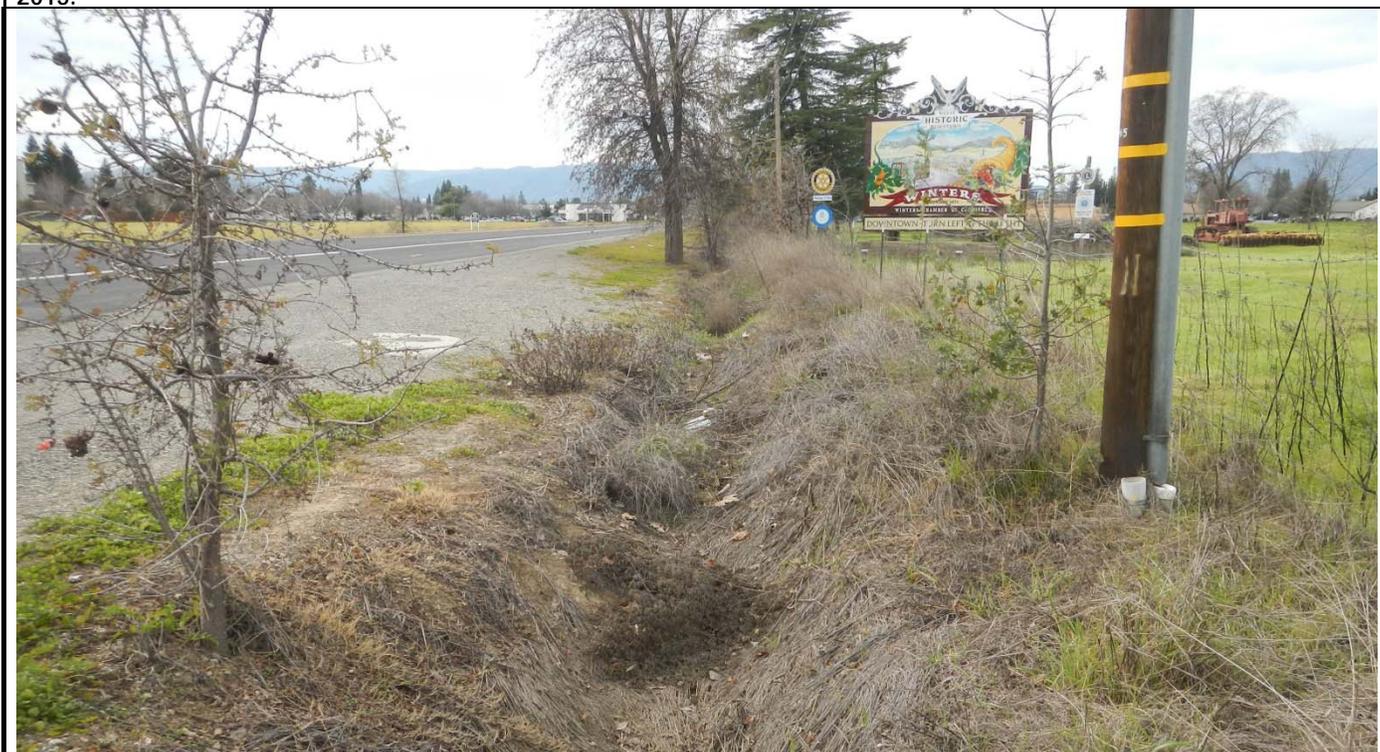
Photo 2. Stormwater ditch feature (riverine unconsolidated bottom, RUB-3) at location of DP-4. North side of SR 128, facing west, January 8, 2015.

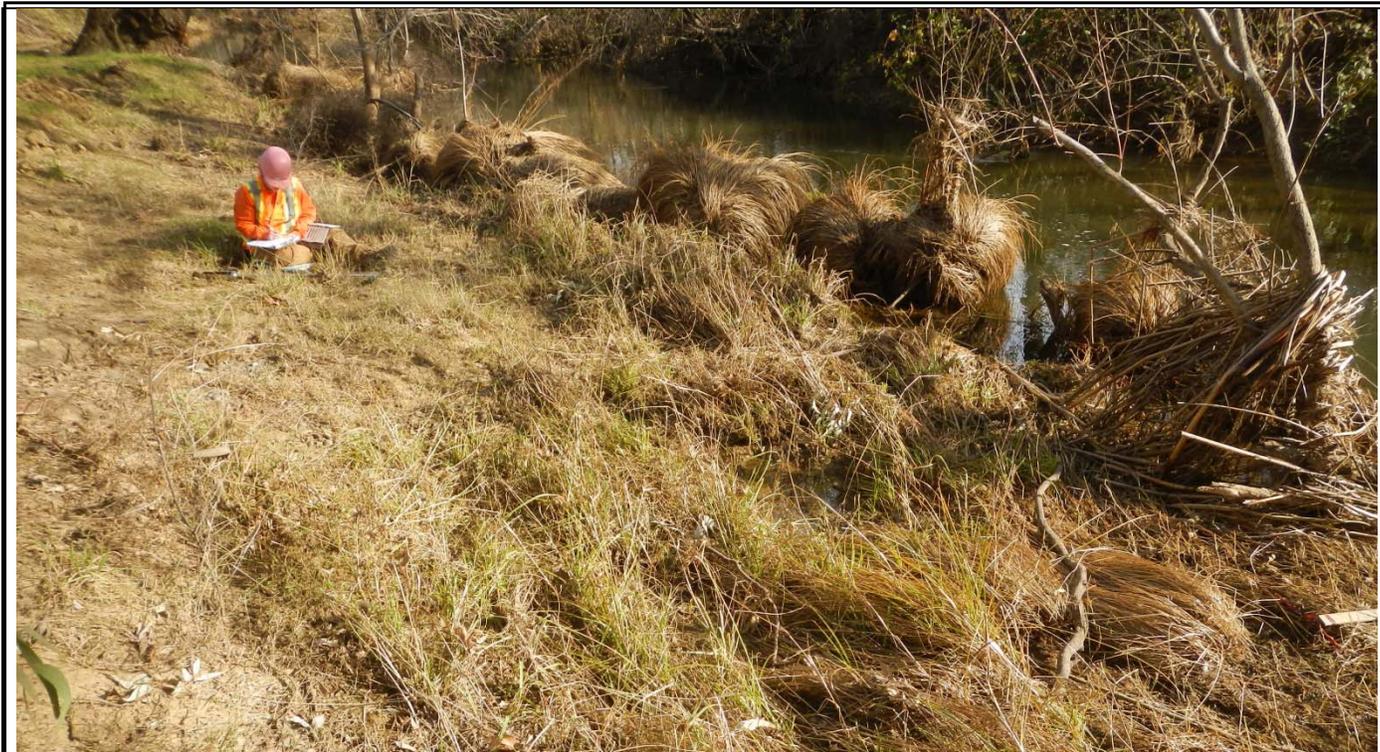
Photo 3. Riverine emergent wetland feature (REM-1) at location of DP-5. North side of Putah Creek (seen in background), facing east, January 8, 2015.

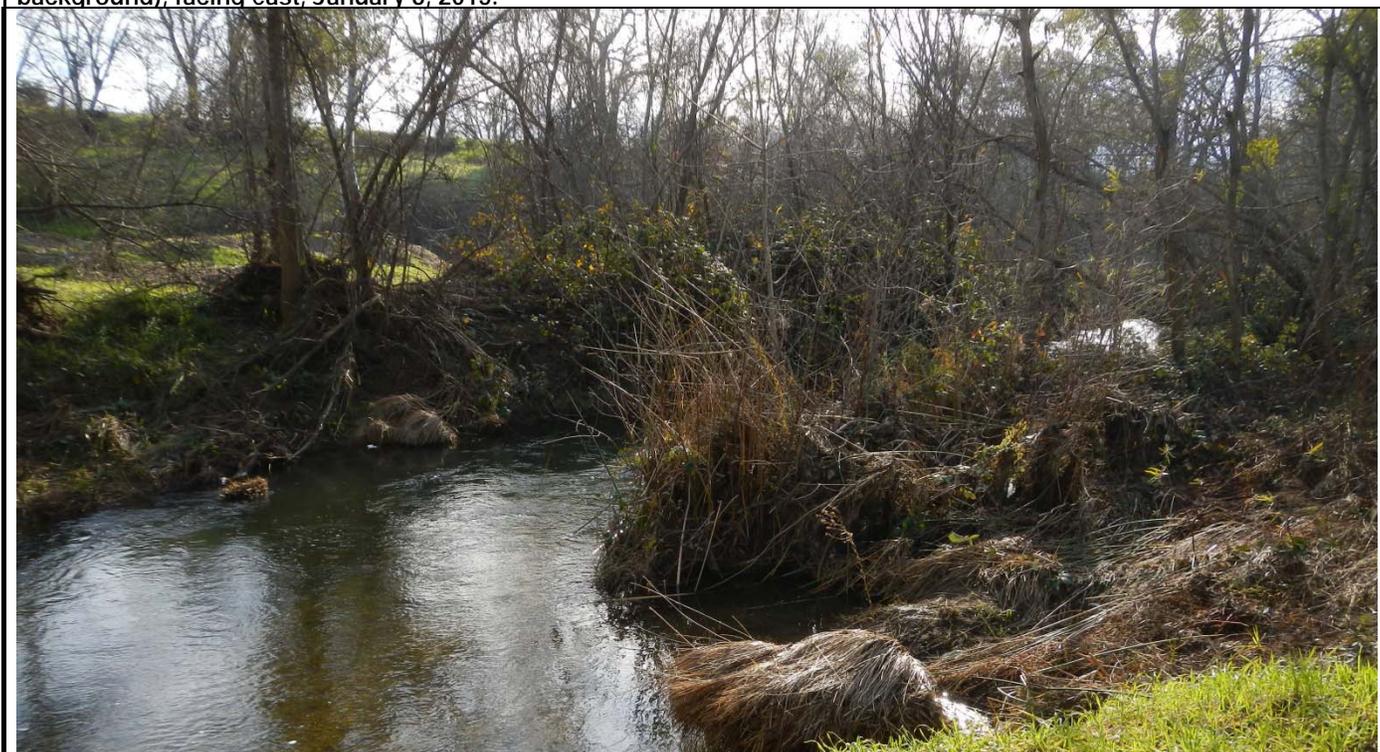
Photo 4. Open water of Putah Creek (RUB-15) on left, next to riverine shrub-scrub wetland (RSS-1) on right. North side of Putah Creek, facing west, January 8, 2015.

One riverine shrub–scrub wetland feature (RSS-1) was mapped within the Delineation Area. It had an area of 0.098 acre (Table 2). This feature was located on a low terrace within the OHWM of Putah Creek on the north bank. While “riparian forest” and “riparian scrub” was widely present along the creek channel, only this single location was observed and mapped where the shrub–scrub vegetation also had indicators of wetland hydrology and hydric soils.

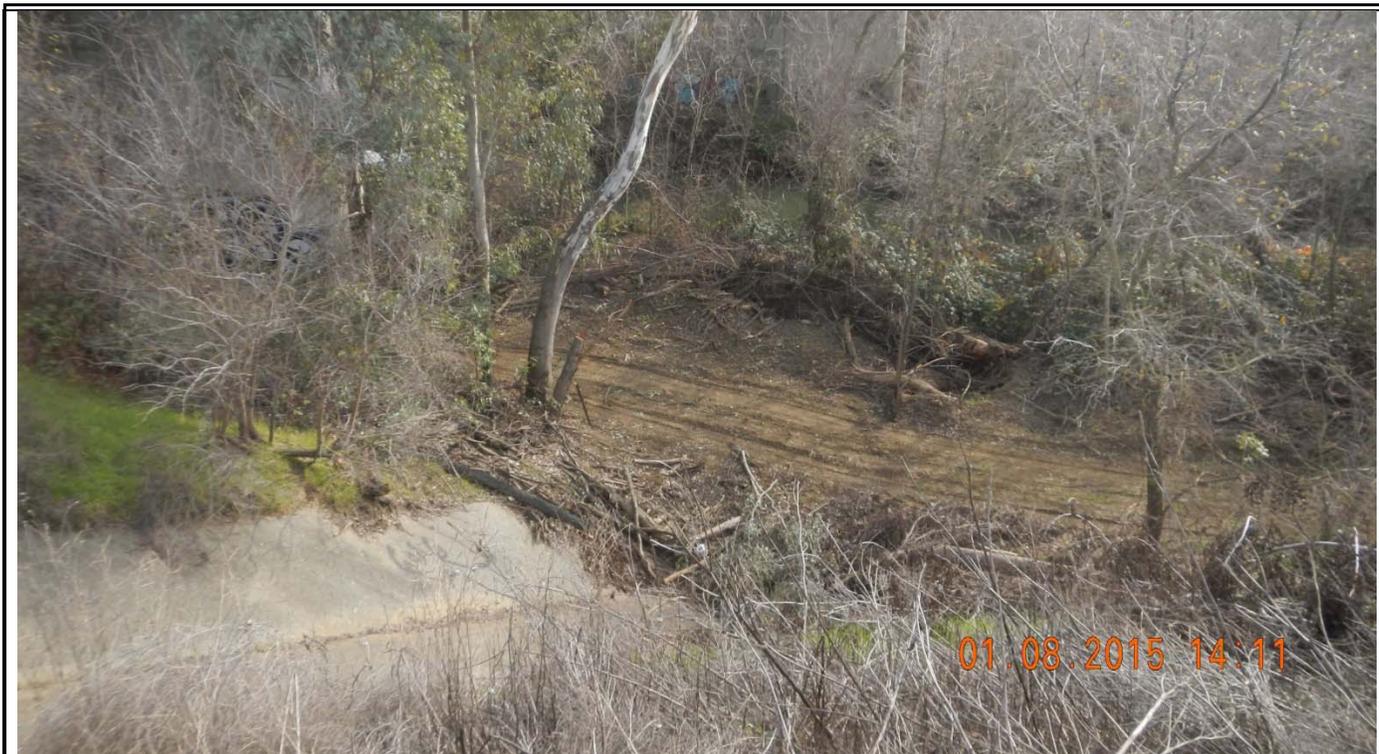
Photo 5. Man-made concrete channel in left foreground (Rr-1) leads downhill to small forested channel in right background (RUS-1). North side of Putah Creek (seen in background), facing southeast, January 8, 2015.

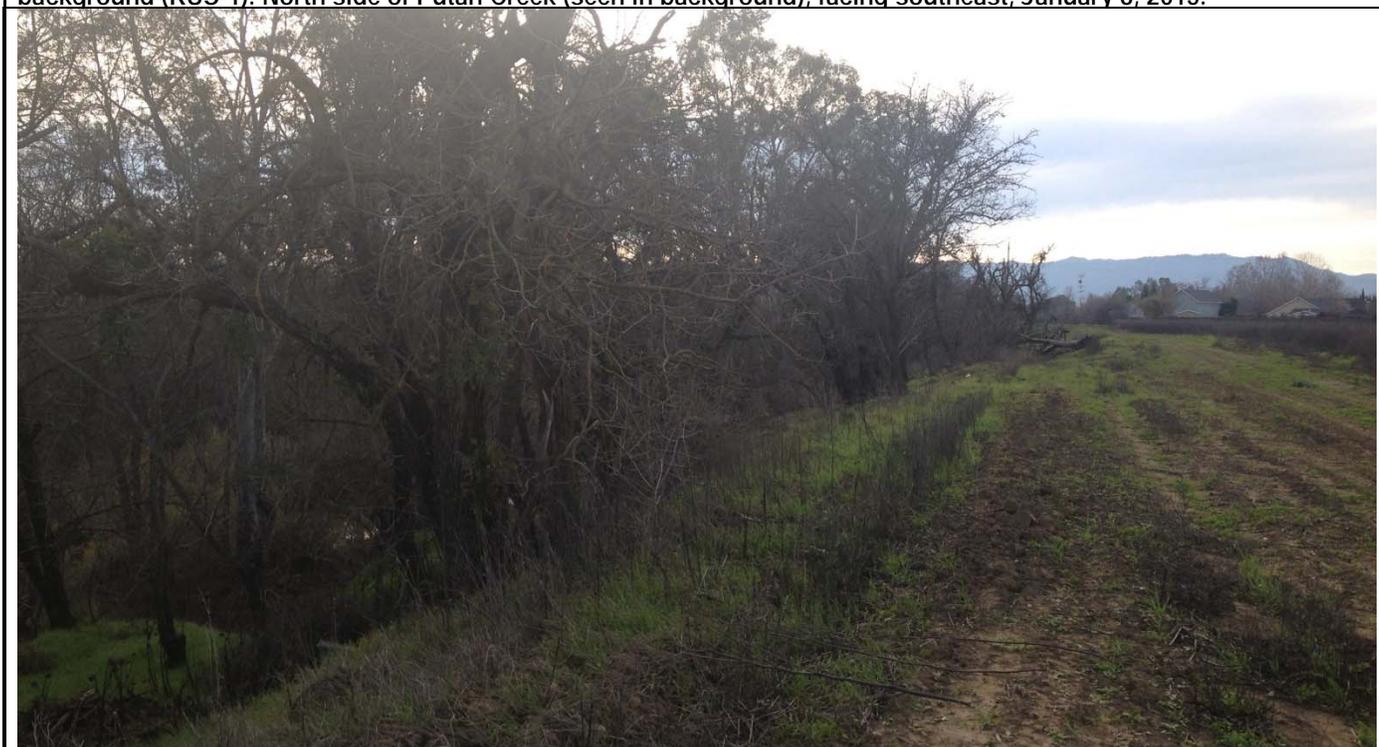
Photo 6. Upland riparian forest below top of bank of Putah Creek (left). Ruderal vegetation and fallow fields above top of bank (right). Facing west, January 8, 2015.

Between the ordinary high water mark (OHWM) and the top of bank of Putah Creek, the uplands supported riparian vegetation; this varied from dense, almost impenetrable shrub–scrub areas, to open forest with well-spaced trees. Overstory trees included tree-of-heaven, river red gum (*Eucalyptus camaldulensis*), Oregon ash (*Fraxinus latifolia*), black walnut (*Juglans hindsii*), Fremont's cottonwood (*Populus fremontii*), valley oak, black elderberry (*Sambucus nigra*), and Chinese tallow tree (*Triadica sebifera*). Understory shrubs and perennials included Douglas' wormwood (*Artemisia douglasiana*), giant-reed (*Arundo donax*), Himalayan blackberry (*Rubus armeniacus*), and Pacific poison oak (*Toxicodendron diversilobum*). Common understory herbs included wild oat, smooth crab grass, dove's foot geranium, English plantain (*Plantago lanceolata*), and Johnson grass.
